Multi-faceted Inspection and Retrofit Project Improves Performance and Reduces Emissions at El Segundo

By: Marc Kodis, El Segundo Power, LLC; Tim Webster, John Zink Company, LLC; Paul Dirks, Source California.

Power Engineering July, 2002

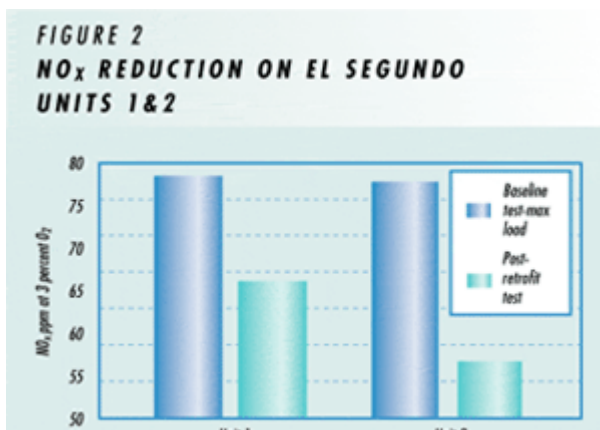
El Segundo Units 1 and 2, Figure 1, constructed in 1953, have balanced draft Babcock & Wilcox (B&W) radiant type, single steam drum, bent tube boilers. Each boiler has a continuous rated steam generating capacity of 1,140,000 lb/hr with superheater outlet conditions of 1,990 psig and 1,000 F and a reheat temperature of 1,000 F.
